MARYLAND HISTORICAL TRUST ADDENDUM SHEET Montgomery-Prince George's Short-term Congestion Relief

Property Name: Miller House Survey No.: M:28-7-1

Property Address 18000 New Hampshire Avenue, Ashton, Montgomery County Owner Name/Address David and Y.S. Taylor / 18000 New Hampshire Avenue, Ashton, MD 20861 Year Built 1918

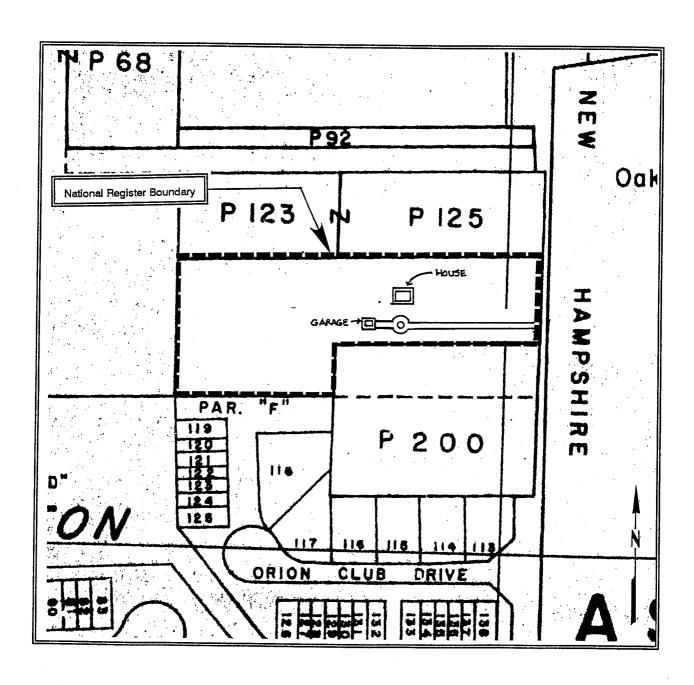
Resource Sketch Map and National Register Boundary Map:

The National Register boundaries of the Miller House follow the current property lines of 18000 New Hampshire Avenue (Tax Map JT 342 / Parcel P177). This .8 hectare (2 acre) parcel is bounded on the north and south by open space and residential property, and on the west by forested land. The boundary includes the house and garage, both contributing structures. According to deed research, the property was originally part of an .8 hectare (2 acre) parcel which was purchased by Francis Miller in 1915.

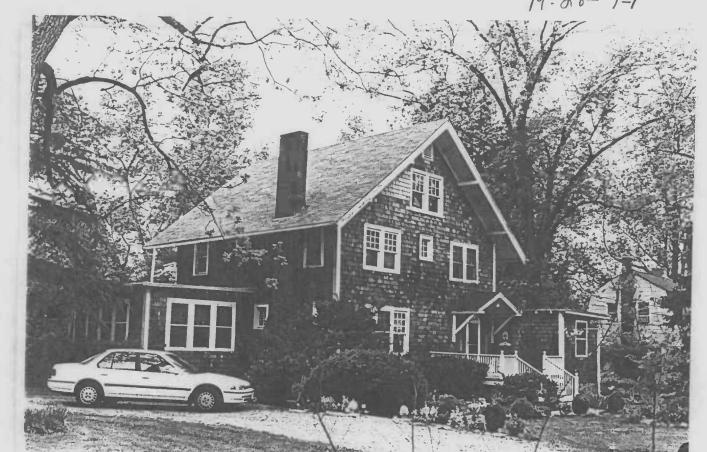
1 Minds 1.1
2 Danious Millio Property
3 Mintering Co Md
4 Juni Lamburino
5 5/97
6 Md 8HPO
7 18000 New Hampshire Are, front
8 1 7-9

The east, or front facade has an entry porch at the northeast corner. The wood porch rests on brick piers and has a wood railing. Above the entry is a front-gable roof supported by three wood knee-braces. The glass front door has a Prairie-style light configuration. The door is flanked by sidelights, also with a Prairie-style light configuration. The first story has a triple 9/1 double-hung window. The second story has two pairs of 9/1 double-hung windows and a 6-light casement window. The attic level of the gable end has a pair of 6/1 double-hung window. The east elevation of the 1-story south addition has a triple 9/1 double-hung window. The east elevation has a concrete block foundation. The triple 9/1 double-hung window on the front elevation of the addition are original windows which were reused when the addition was constructed circa 1930. The remaining windows on the addition are 6/6 double-hung. The east elevation of the north addition has a 6/6 double-hung window. The north addition has a stone foundation and 8/8 and 6/6 double-hung windows.

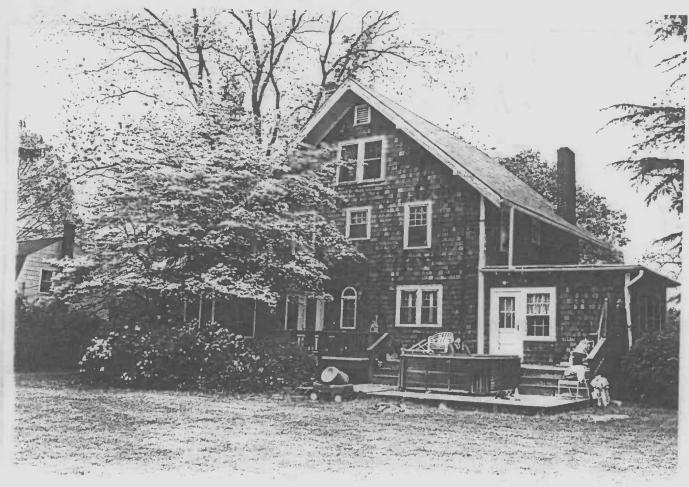
1 M. 2 8. ...
2 Grave Miller Corping
3 Mintgomery Co Md
4 Jim Jamburine
5 5/92
6 Md 24P3
7 18810 New Hampshus Ave. S. elevation
8 3079

The south elevation has two 6-light casement windows on the first story. The second story has two 9/1 double-hung windows and a 6-light casement window. The south elevation of the south addition has a triple 6/6 double-hung window. The south elevation of the enclosed rear porch has double vinyl doors.

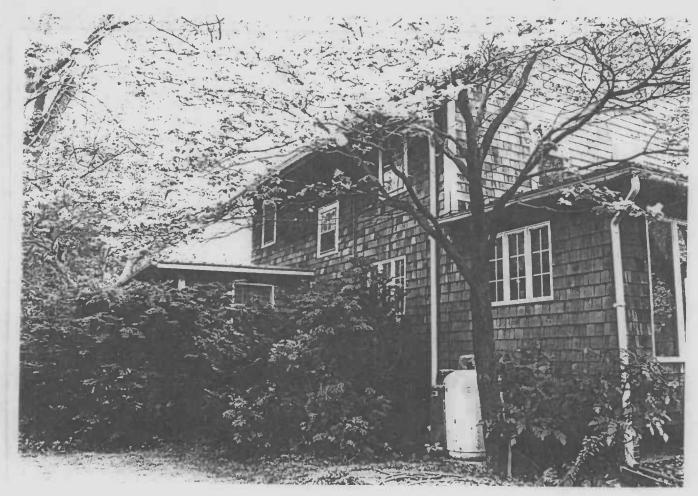
1 N 28 11 1
2 drawing Miller Property
3 Maganery Co. Ald
4 Sim Fambrerian
5 5/1118
5 Md SHP
7 18000 New Hampshir Ave, Rear elevator
8 509 9

The rear elevation has a pair of double casement windows with a Prairie-style light configuration and a vinyl round-headed window on the first story. The second story has two 9/1 double-hung windows and a 6/1 double-hung window, while the attic level has a pair of 6/1 double-hung windows. The south addition has a 6-light wood panel door and a 6/6 double-hung window. The north addition has an 8/8 double-hung window. The enclosed porch has a vinyl three-part fixed sash window.

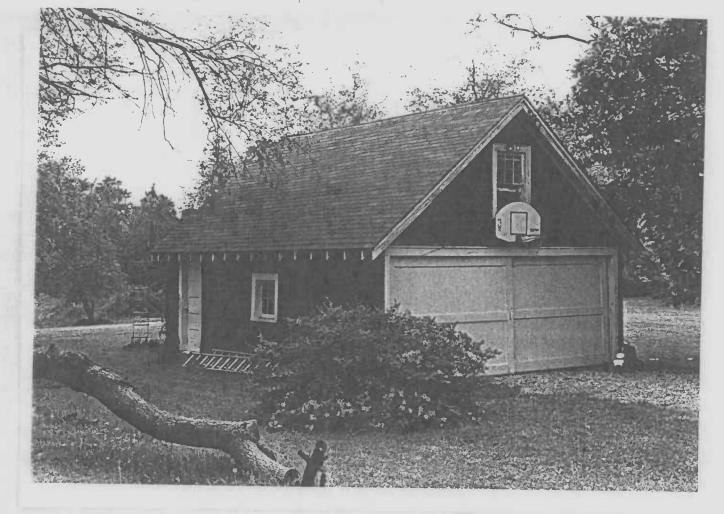
1 1 08 17 2 dennée Mille-Property 3 Matginey a Mi + Jun Frankline 5 5/98 6 Md SHPL 7 18000 Ha Hampshire Are, Surage 89129

There is one outbuilding associated with this property. A garage, constructed in 1918, is located southwest of the house. The wood-frame building has a front-gable roof covered with asphalt shingles, a wood shingle exterior and a concrete slab floor. The garage has a sliding double wood door and a 9/1 double-hung window on the east elevation. The south elevation has a wood door and 9/1 double-hung windows, while the north elevation has a 6-light casement window.
